# Protein purification troubleshooting guide

Pure protein today. Powerful results tomorrow.

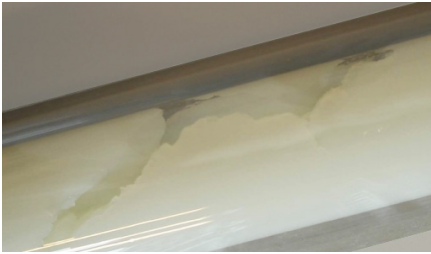
Air in the column

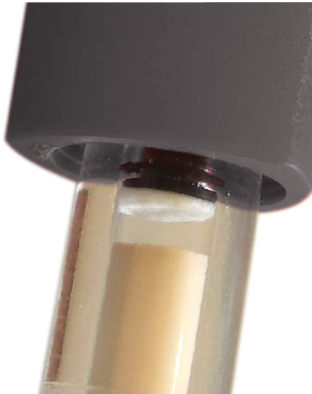
Compressed bed

| Possible cause | Remedy |
|---|---|
| <b>Bed compressed</b> | <ul style="list-style-type: none"> <li>• Clean column according to cleaning procedures and/or change filter</li> <li>• Check sample preparation. If sample is too viscous, back pressure will be high. Dilute sample or reduce flow rate.</li> <li>• Repack column, pack new column, or use prepacked column</li> </ul> |
