Cleaning procedures for ÄKTAprocess system external surfaces

Cleaning procedures for ÄKTApocess system external surfaces

This application note describes studies to determine ÄKTApocess system compatibility with common cleaning processes for external surfaces, including fogging of the entire system. This study does not detail any microbiological decontamination advantages or disadvantages of any of the methods used.

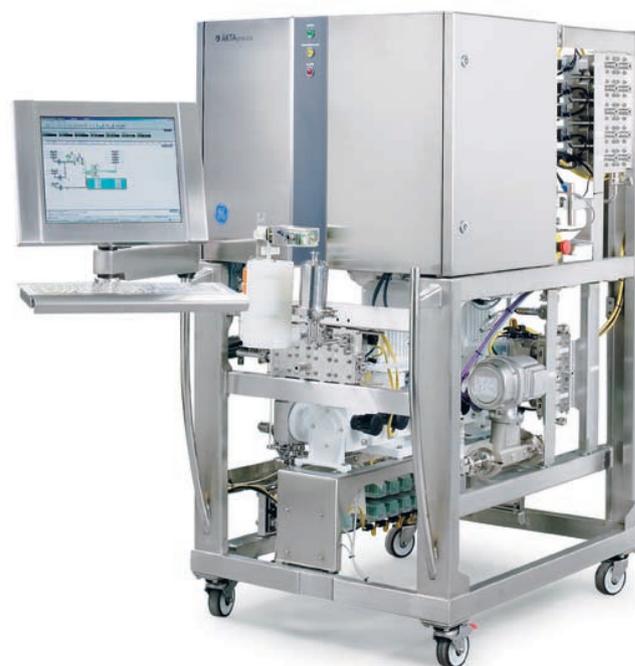
Fig 1. ÄKTApocess system.

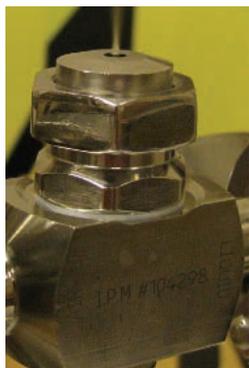
Fig 2. A nozzle applying fogging solution.

Fogging of system components was carried out with a Mini Dry Fog™ System (Fig 2) dispensing Minncare solution (22% hydrogen peroxide, 4% peracetic acid) according to supplier recommendations (contact time = 1 h).

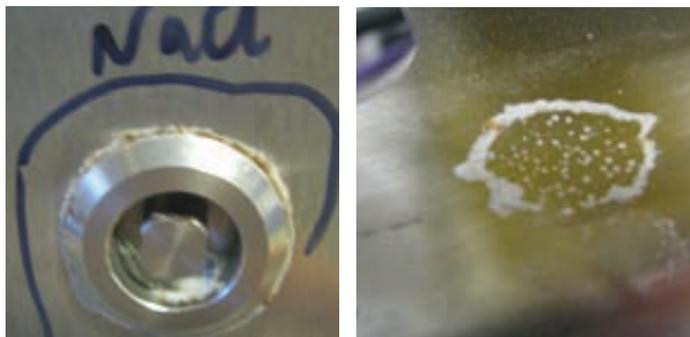
Fogging of an entire ÄKTApocess system gave results similar to the component fogging study - Minncare solution in combination with salt residues tended to exacerbate the rust effect on stainless steel surfaces (e.g., Fig 3).

Fig 3. Examples of incipient rust on areas of salt residue on steel surfaces after fogging.

The results suggest that cleaning of external surfaces (with special attention to steel surfaces) is important before fogging of ÄKTApocess systems. Although the fog slightly penetrated the electrical system cabinet, no effects of the fogging were seen on system functional performance.

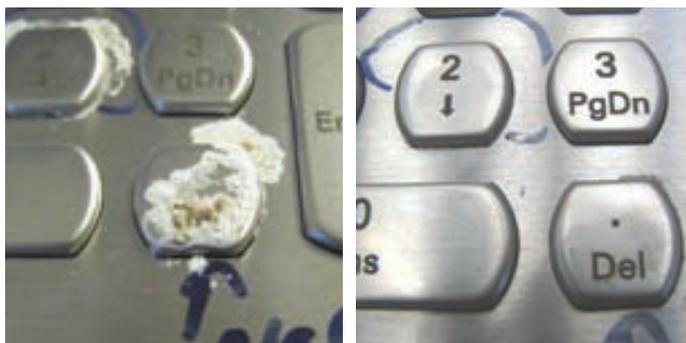
In most cases, residue and rust could be removed with gentle wiping of the surface (Fig 4). No effects were seen on tags, adhesives, or labels.

Fig 4. Areas of salt residue and subsequent rust (left photo) are normally easily removed with gentle cleaning with water (right photo).

1. Regularly wipe/wash off system surfaces with water to remove salt and other external deposits. Note that this step is mandatory prior to performing either of the following procedures!
2. Regularly clean system surfaces with 70% ethanol or 70% isopropanol, and also before placing the system in a clean room environment (according to SOPs).
3. Clean room cleaning techniques may include fogging with Minncare solution (hydrogen peroxide and peracetic acid) according to SOPs.
